# Manhole Inspection Summary

Manhole # S17A1\_011MH

Insp Date: **6/24/08 8:49 AM**

**Location** Address: **2624 washington bd**

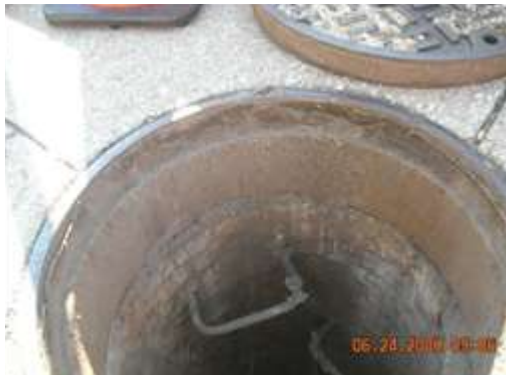
Miscellaneous

inflow evidence from sheeting

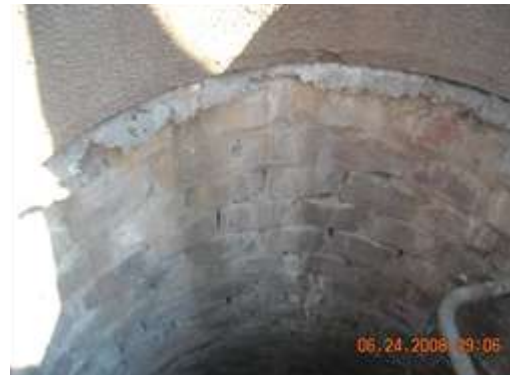
Defect 1

Infiltration: ☐ None ☐ Joint ☐ Cracks ☐ Mortar ☐ Roots ☒ **Wall**

chimney flow wall /frame joint

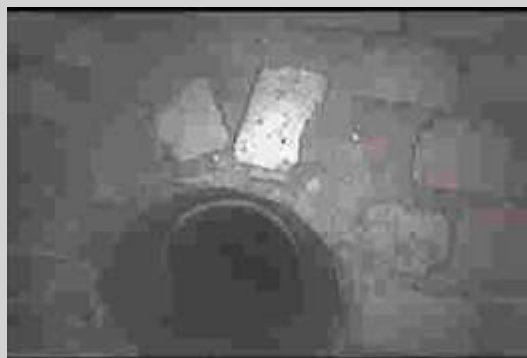
12 O'Clock Outflow

8 in. Circular Gravity Sewer  
Pipe Out @ 12 O'Clock

Infiltration: **None** Pipe Seal Cond: **Sound**
